Date: January 05, 2018 Job No.: 5342-09
To: Paul Scott, Director
Department of Public Works
Cc: Robert T. Mackie, P.E., BCEE
From: Kien Ho, P.E., PTOE
Tyler de Ruiter, P.E.
Subject: Plainville – Route 106 at George Street & Route 106 at Route 152 Evaluation

**Route 106 at
George Street &
Route 106 at
Route 152**
Plainville, MA

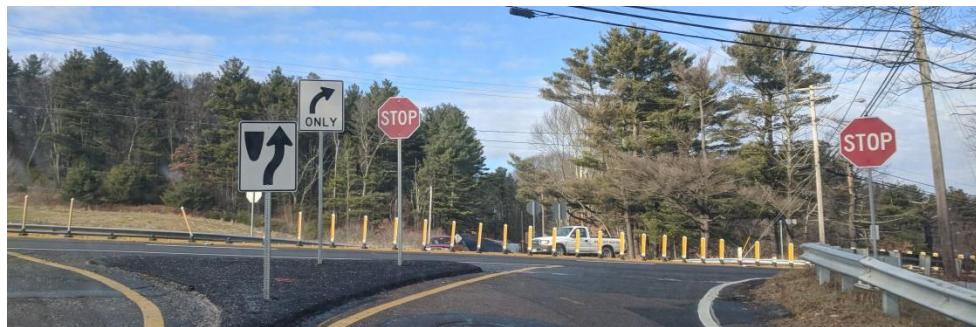
Route 1 at George Street (Looking Northbound)

George Street is an urban collector under Town jurisdiction that generally travels in the north/south direction. Within the study area, George Street connects Messenger Street with Route 1. While George Street continues north of Route 1, traffic along Route 1 is separated by a row of delineators which prohibit crossing traffic between the southern and northern portions of George Street. The delineators also prohibit left turns on to and off of Route 1 establishing a "right-in, right-out" condition for both George Street approaches. The roadway generally provides one travel lane in each direction separated by double yellow center line. Shoulders were found to be variable in width. Sidewalk is provided along the west side of George Street south of Route 106.

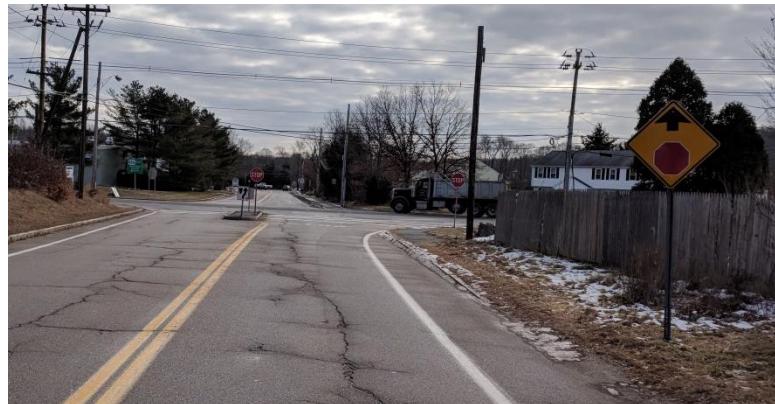
George Street (Looking Southbound)

At the intersection with Route 106, a raised median island is provided on the northern George Street approach. The median island provides separation between southbound vehicles exiting George Street and a large number (112 vph) of westbound right turning vehicles towards George Street. Both George Street approaches flare out to provide wider turning radii. A crosswalk is provided along the northern leg of George Street that proceeds through the median island. An "Intersection Ahead" (W2-1) sign is provided approaching the intersection from the east. A "Stop Ahead" (W3-1A) sign is provided approaching Route 106 from the north and south.

The northern leg provides two "STOP" (R1-1) signs with one in the median and one in the sidewalk. A large "STOP" pavement marking is provided on both north and south legs of George Street. The Stop Line on this approach was found to be approximately 10 feet north of the crosswalk. Based on this stop line location, sight distance exiting the northern leg is obstructed by vegetation and utility poles looking east and a large tree looking west. Vehicles were observed pulling up into the crosswalk to maximize sight distance. The southern leg provides an oversized "STOP" (R1-1) sign. Sight distance approaching from the south is also inhibited by large trees and an embankment on the eastern side. The intersection is lit by one street lamp on a utility pole located on the northeastern corner.

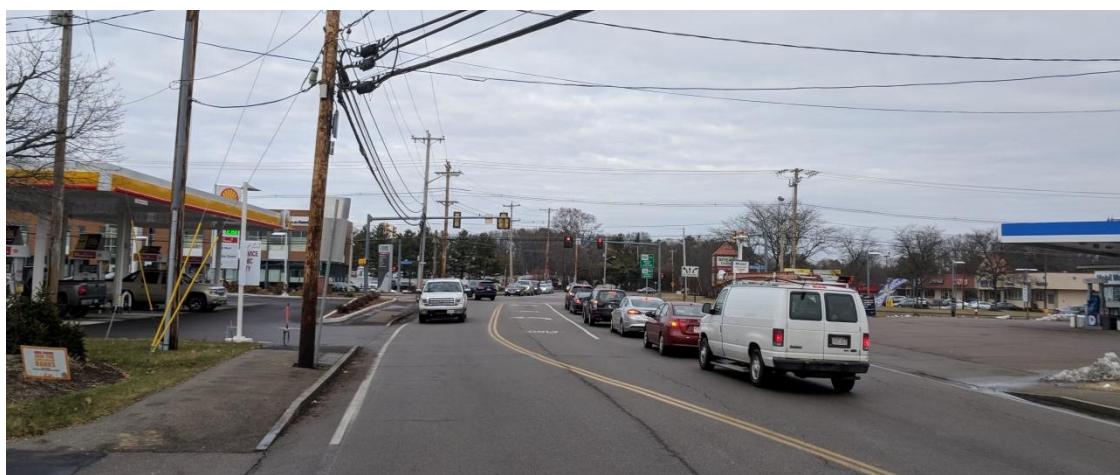
Route 152 (Looking Northbound)

In the area of its intersection with Route 106, Route 152 generally provides one travel lane in each direction separated by a double yellow center line. South of Route 106, the roadway provides a two way left turn lane which provides access to several commercial businesses and commercial parks. The southern leg of Route 152 provides a left turn lane, through lane, and right turn lane. All other approaches provide a left turn lane and a shared through/right turn lane. Crosswalks are provided across all four legs of the intersection. Sidewalks are provided along all four corners of the intersection and along both sides of all four legs. An additional pedestrian crossing is located approximately 375 feet north of Route 106 connecting the Plainville Crossing Shopping Center with Killarny Drive. Utility poles are located along the north side of Route 106 and the west side of Route 152. Most of the utility poles are located along the front of sidewalk within two feet of the existing curb line though some poles are located further set back from the roadway behind the sidewalk.

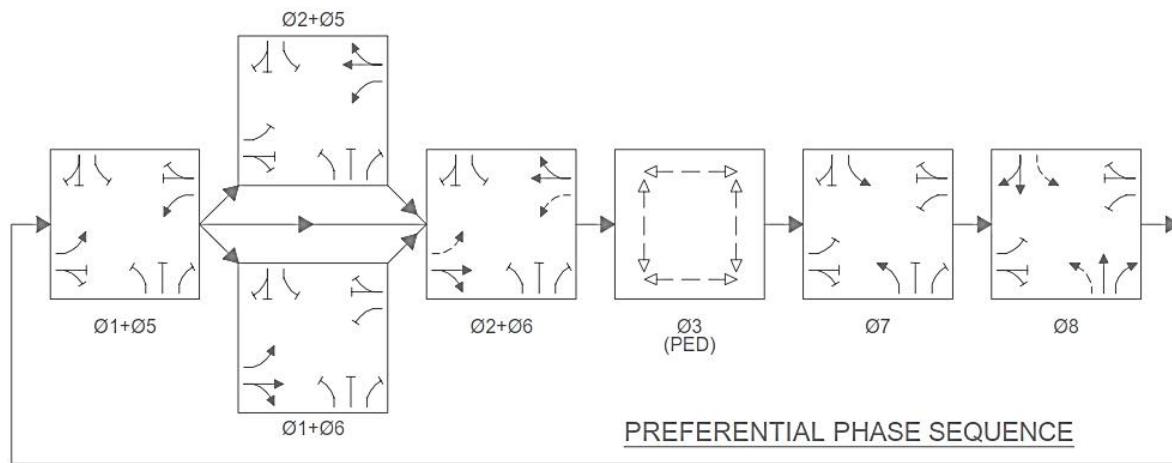
Figure 2: Existing Traffic Signal Phasing

The intersection operates with a fully actuated traffic signal with two time-of-day signal timing plans. One plan is used between 3:30PM and 6:00PM while the other plan is used during all other times. The signal operates with seven phases, as shown in Figure 2. A left turn advance phase is provided for each approach. In addition, left turns are permitted during the regular through phases for each approach which is denoted by "Left Turn Yield on Green Ball" (R10-12) signs on each mast arm. Each mast arm provides a 5-Section

"Doghouse" type signal head arrangement to display the protected-permitted left turn configuration. An exclusive pedestrian phase (Ø3) is provided via pushbutton activation that stops all vehicles such that pedestrians may cross any approach. It should be noted that the Route 152 northbound and southbound phases are combined in Phases 7 and 8. For example, should a southbound vehicle call Phase 7 (the left turn advance) both the southbound and northbound left turns would receive a green signal. However, a singular eastbound left turn would only trigger the eastbound left turn green signal while skipping the westbound left turn.

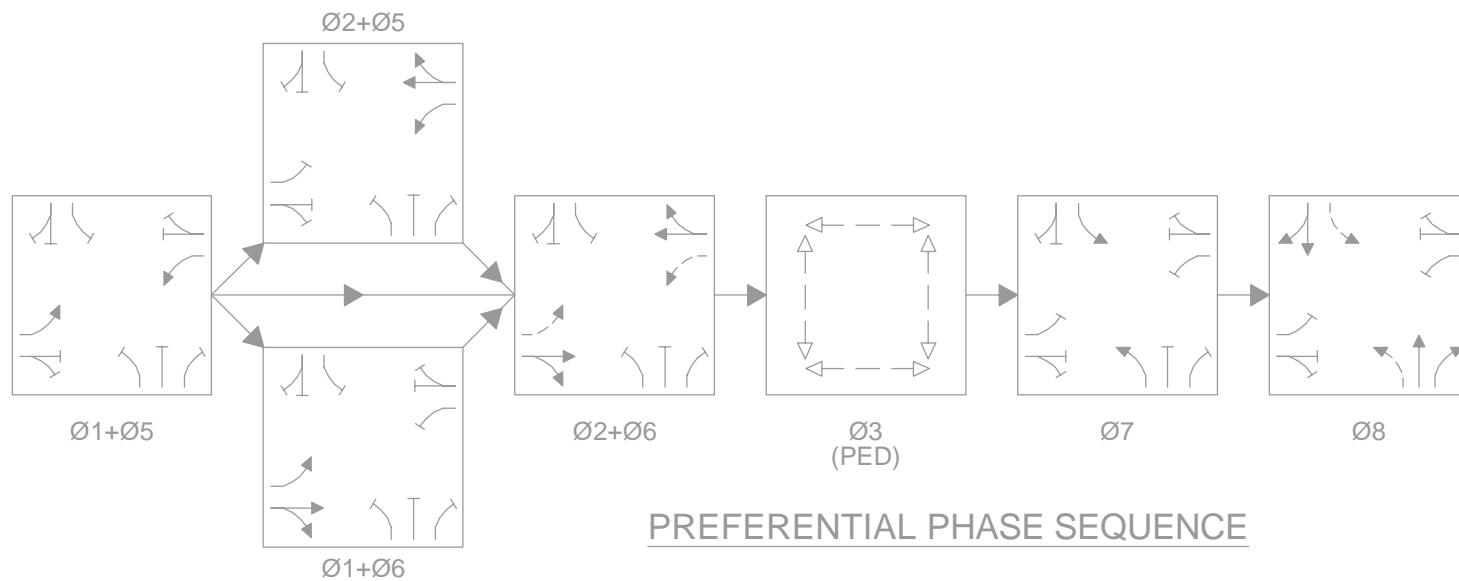
Figure No. 2A

TIMING IN SECONDS																														
MINIMUM GREEN			5			15								5		15		5		10										
VEHICLE EXTENSION			2			2								2		2		2		3										
MAXIMUM GREEN 1			10			40								12		38		10		32										
MAXIMUM GREEN 2			10			36								16		32		10		40										
YELLOW CHANGE			3			3								3		3		3		3										
RED CLEARANCE					1			2							2		1		2		2									
WALK INTERVAL						7																								
PEDESTRIAN CLEARANCE						16																								
RECALL			OFF		OFF	OFF								OFF		OFF	OFF	OFF	OFF											
MEMORY			NON-LOCK		NON-LOCK	LOCK								NON-LOCK		NON-LOCK	NON-LOCK	NON-LOCK												
	CYCLE*	TIME PERIOD

**Route 106 at 152
Existing Timing**

Full timing data for this intersection is provided in Figure 2A.

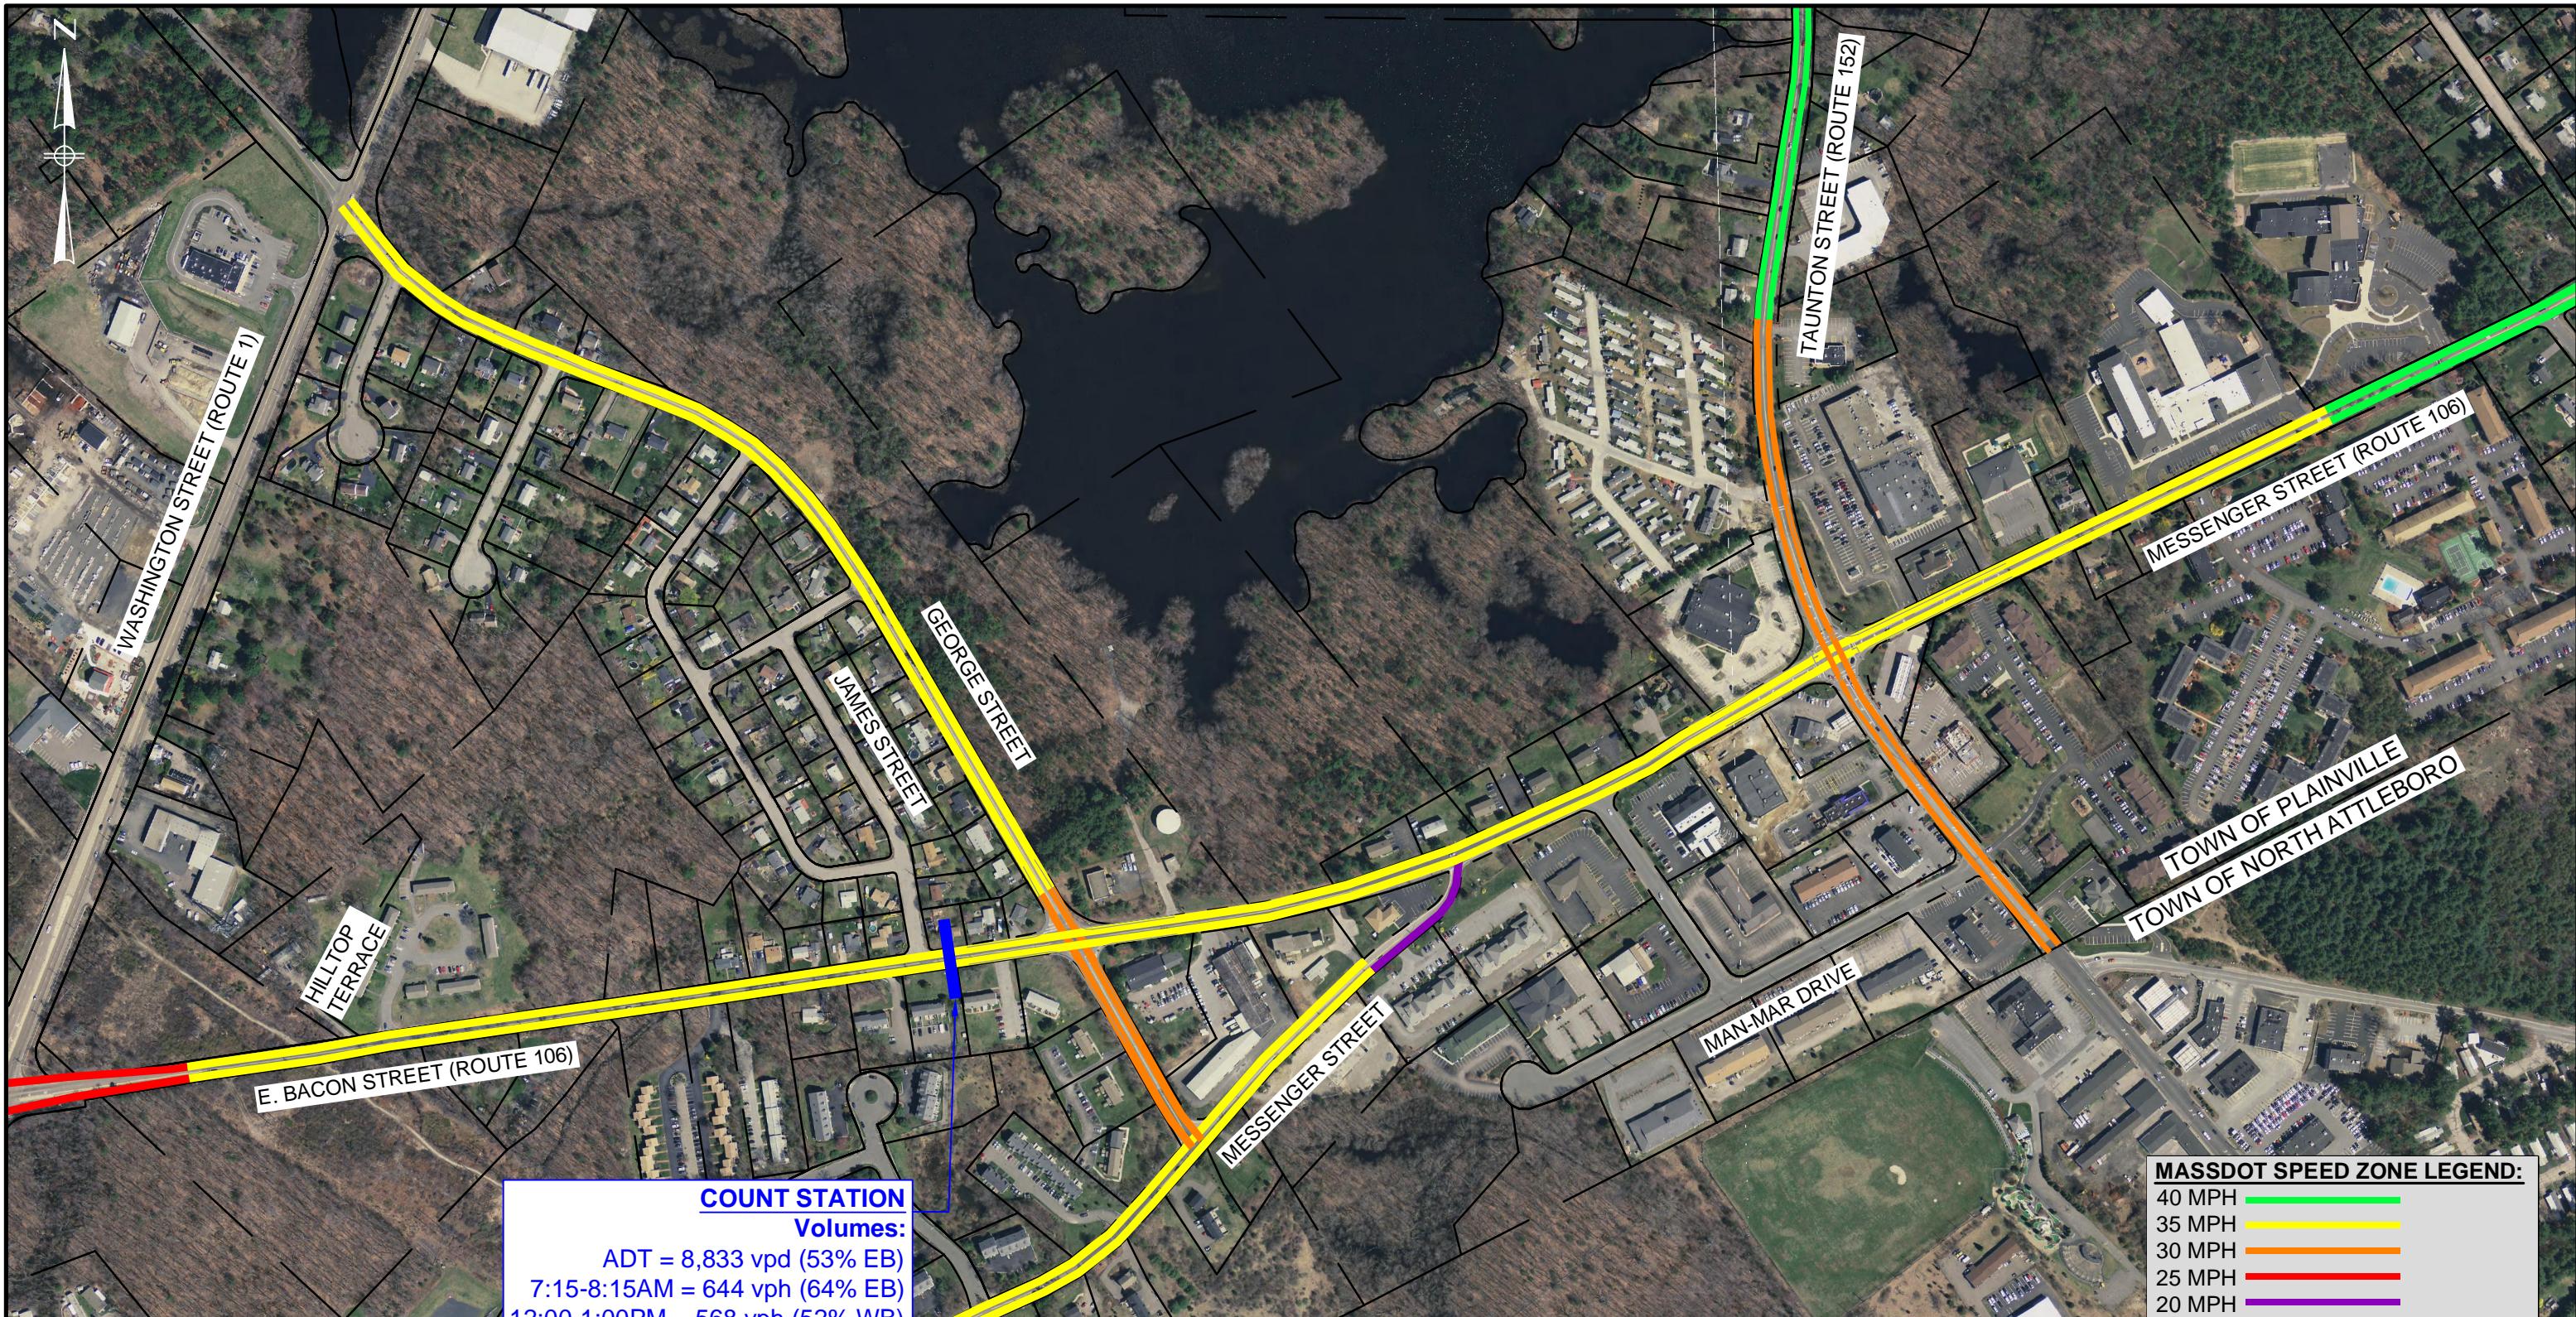
MASSDOT SPEED LIMIT ZONE NOTES:

- TOWN OF PLAINVILLE SPECIAL SPEED REGULATION NO. 5005; DATED DECEMBER 29, 1978; FOR ROUTE 106, ROUTE 152, AND MESSENGER STREET
- TOWN OF PLAINVILLE SPECIAL SPEED REGULATION NO. 7127; DATED AUGUST 11, 1982; FOR GEORGE STREET

Traffic speeds are summarized in Figure 3 which shows a comparison of regulatory speed limits established by the Town of Plainville and MassDOT. Within the study area, Route 106 has a regulatory speed limit of 35 miles per hour (mph) in both directions. At the data collection location, the ATR found 85th percentile speeds to be approximately 48 mph eastbound and 46 mph westbound, more than 10 mph higher than the regulatory speed limit. As noted previously, these high speeds are contributed by the downgrade approaching from the west and the wide roadway which provides approximately 43 feet of pavement width in this area.

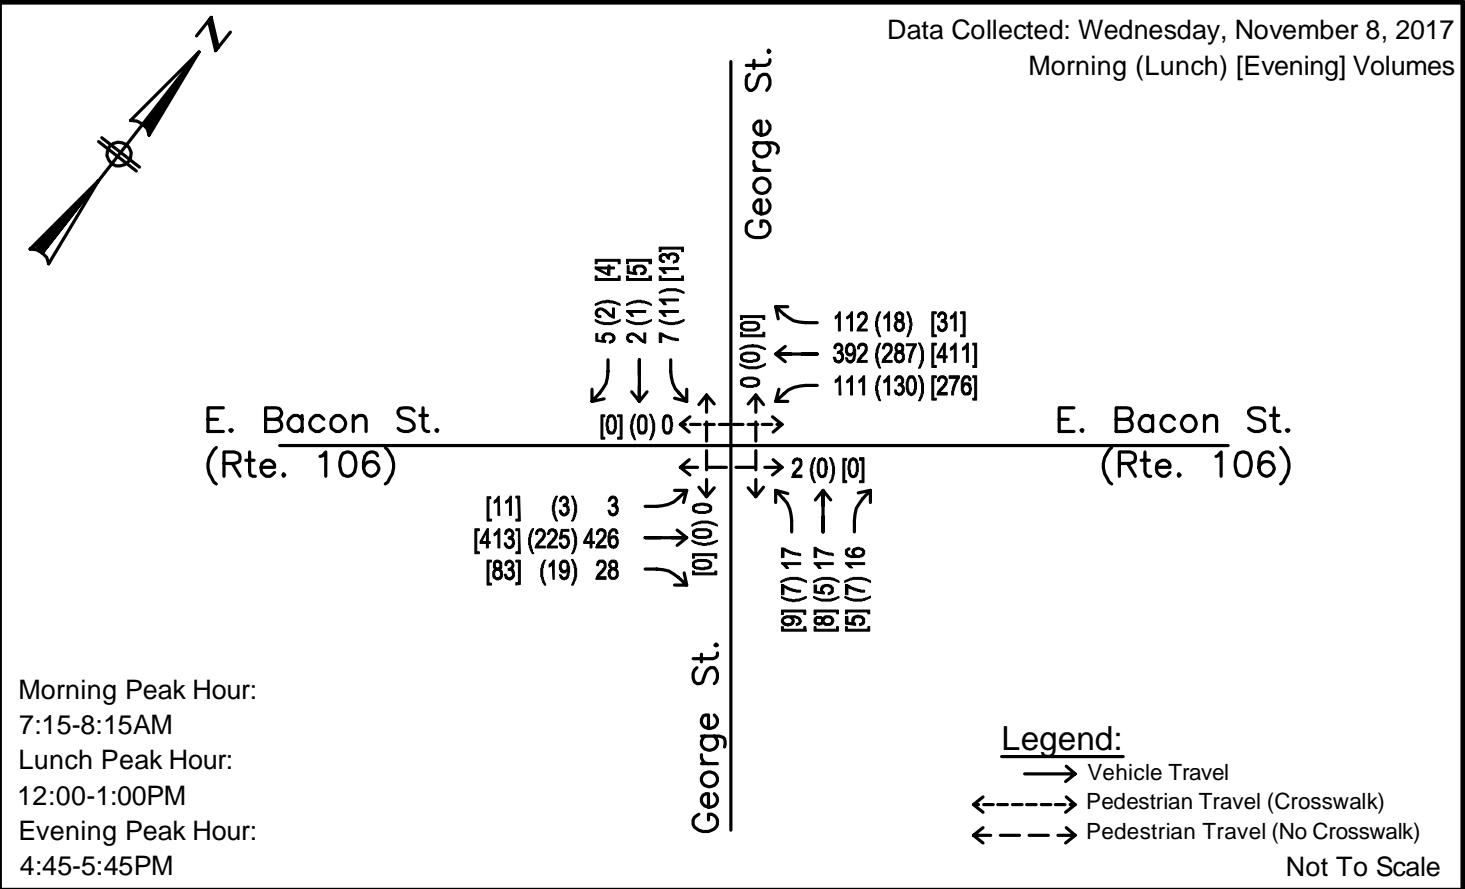
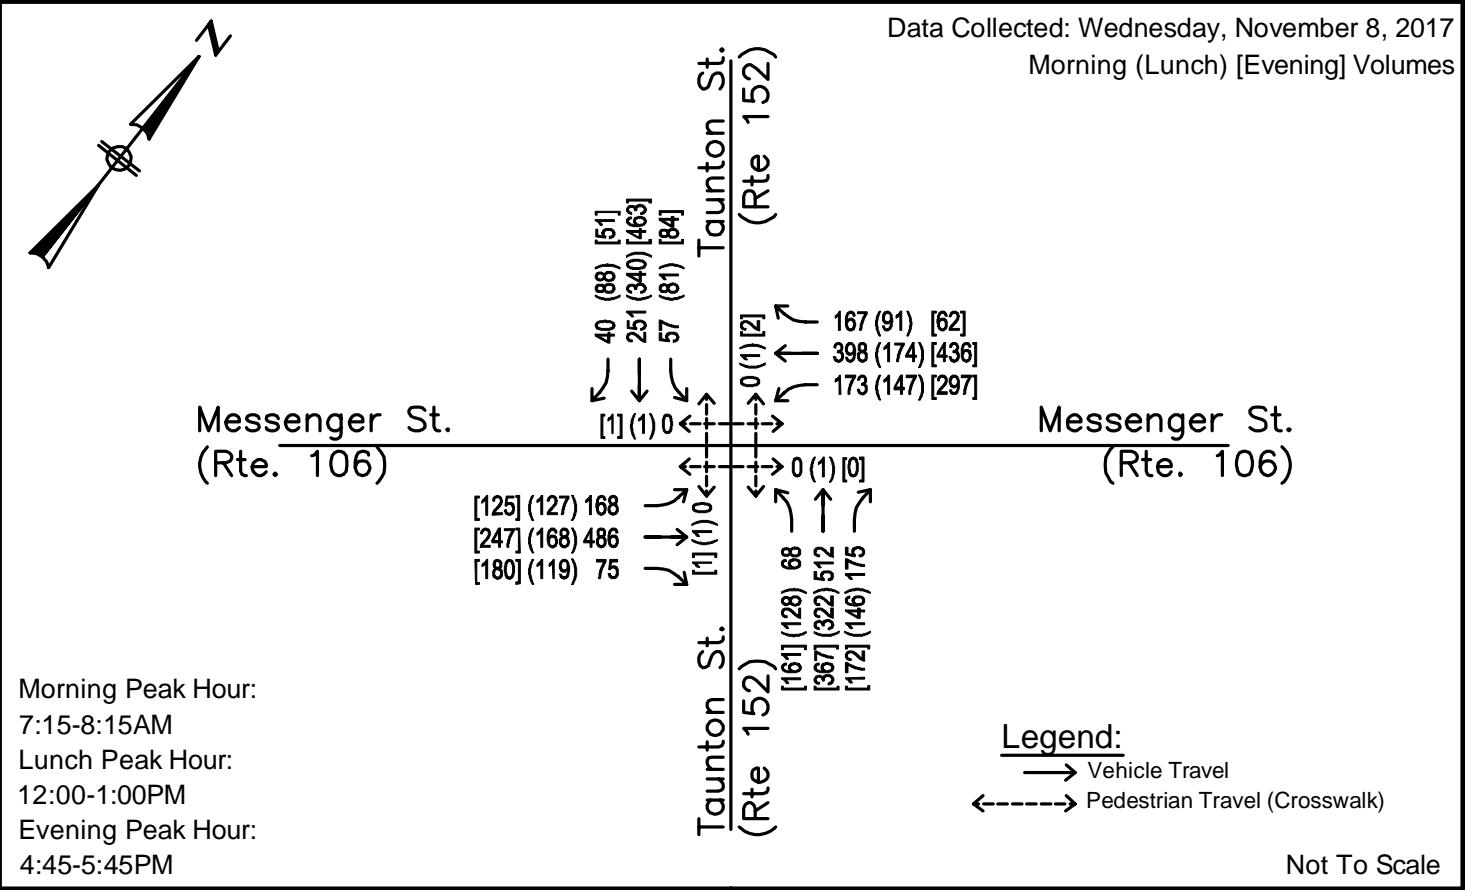
Turning movement counts (TMC) were collected on Wednesday, November 8th 2017 at the intersections of Route 106 at George Street and Route 106 at Route 152. The intersection of George Street was continuously counted for 11 hours from 7:00AM to 6:00PM. The intersection of Route 152 was counted for the morning, lunch, and evening peak periods of 7:00-9:00AM, 12:00-2:00PM, and 4:00-6:00PM. A summary of the peak hour turning movement counts for both intersections are provided in Figure 4. As noted in the figure, the peak hours for both intersections were found to be 7:15-8:15AM, 12:00-1:00PM, and 4:45-5:45PM.

Due to the restrictive configuration of Route 1 at George Street, the volume exiting George Street onto Route 106 is significantly lower than any of the other roadways. The TMC also validate that eastbound and westbound traffic along Route 106 is relatively similar in each direction during all of the peak hours. Westbound right turns to George Street are significant in the morning peak hour, while westbound left turns to George Street are significant in the evening peak hour.

At the intersection of Route 152, the heavier movements were found to be eastbound and northbound in the morning peak hour, with southbound and westbound traffic in the evening peak hour. Southbound turns were found to be lower than all other approaches, possibly due to the presence of alternative routes such as Route 1 and Interstate 495 which may provide quicker travel times to similar areas.

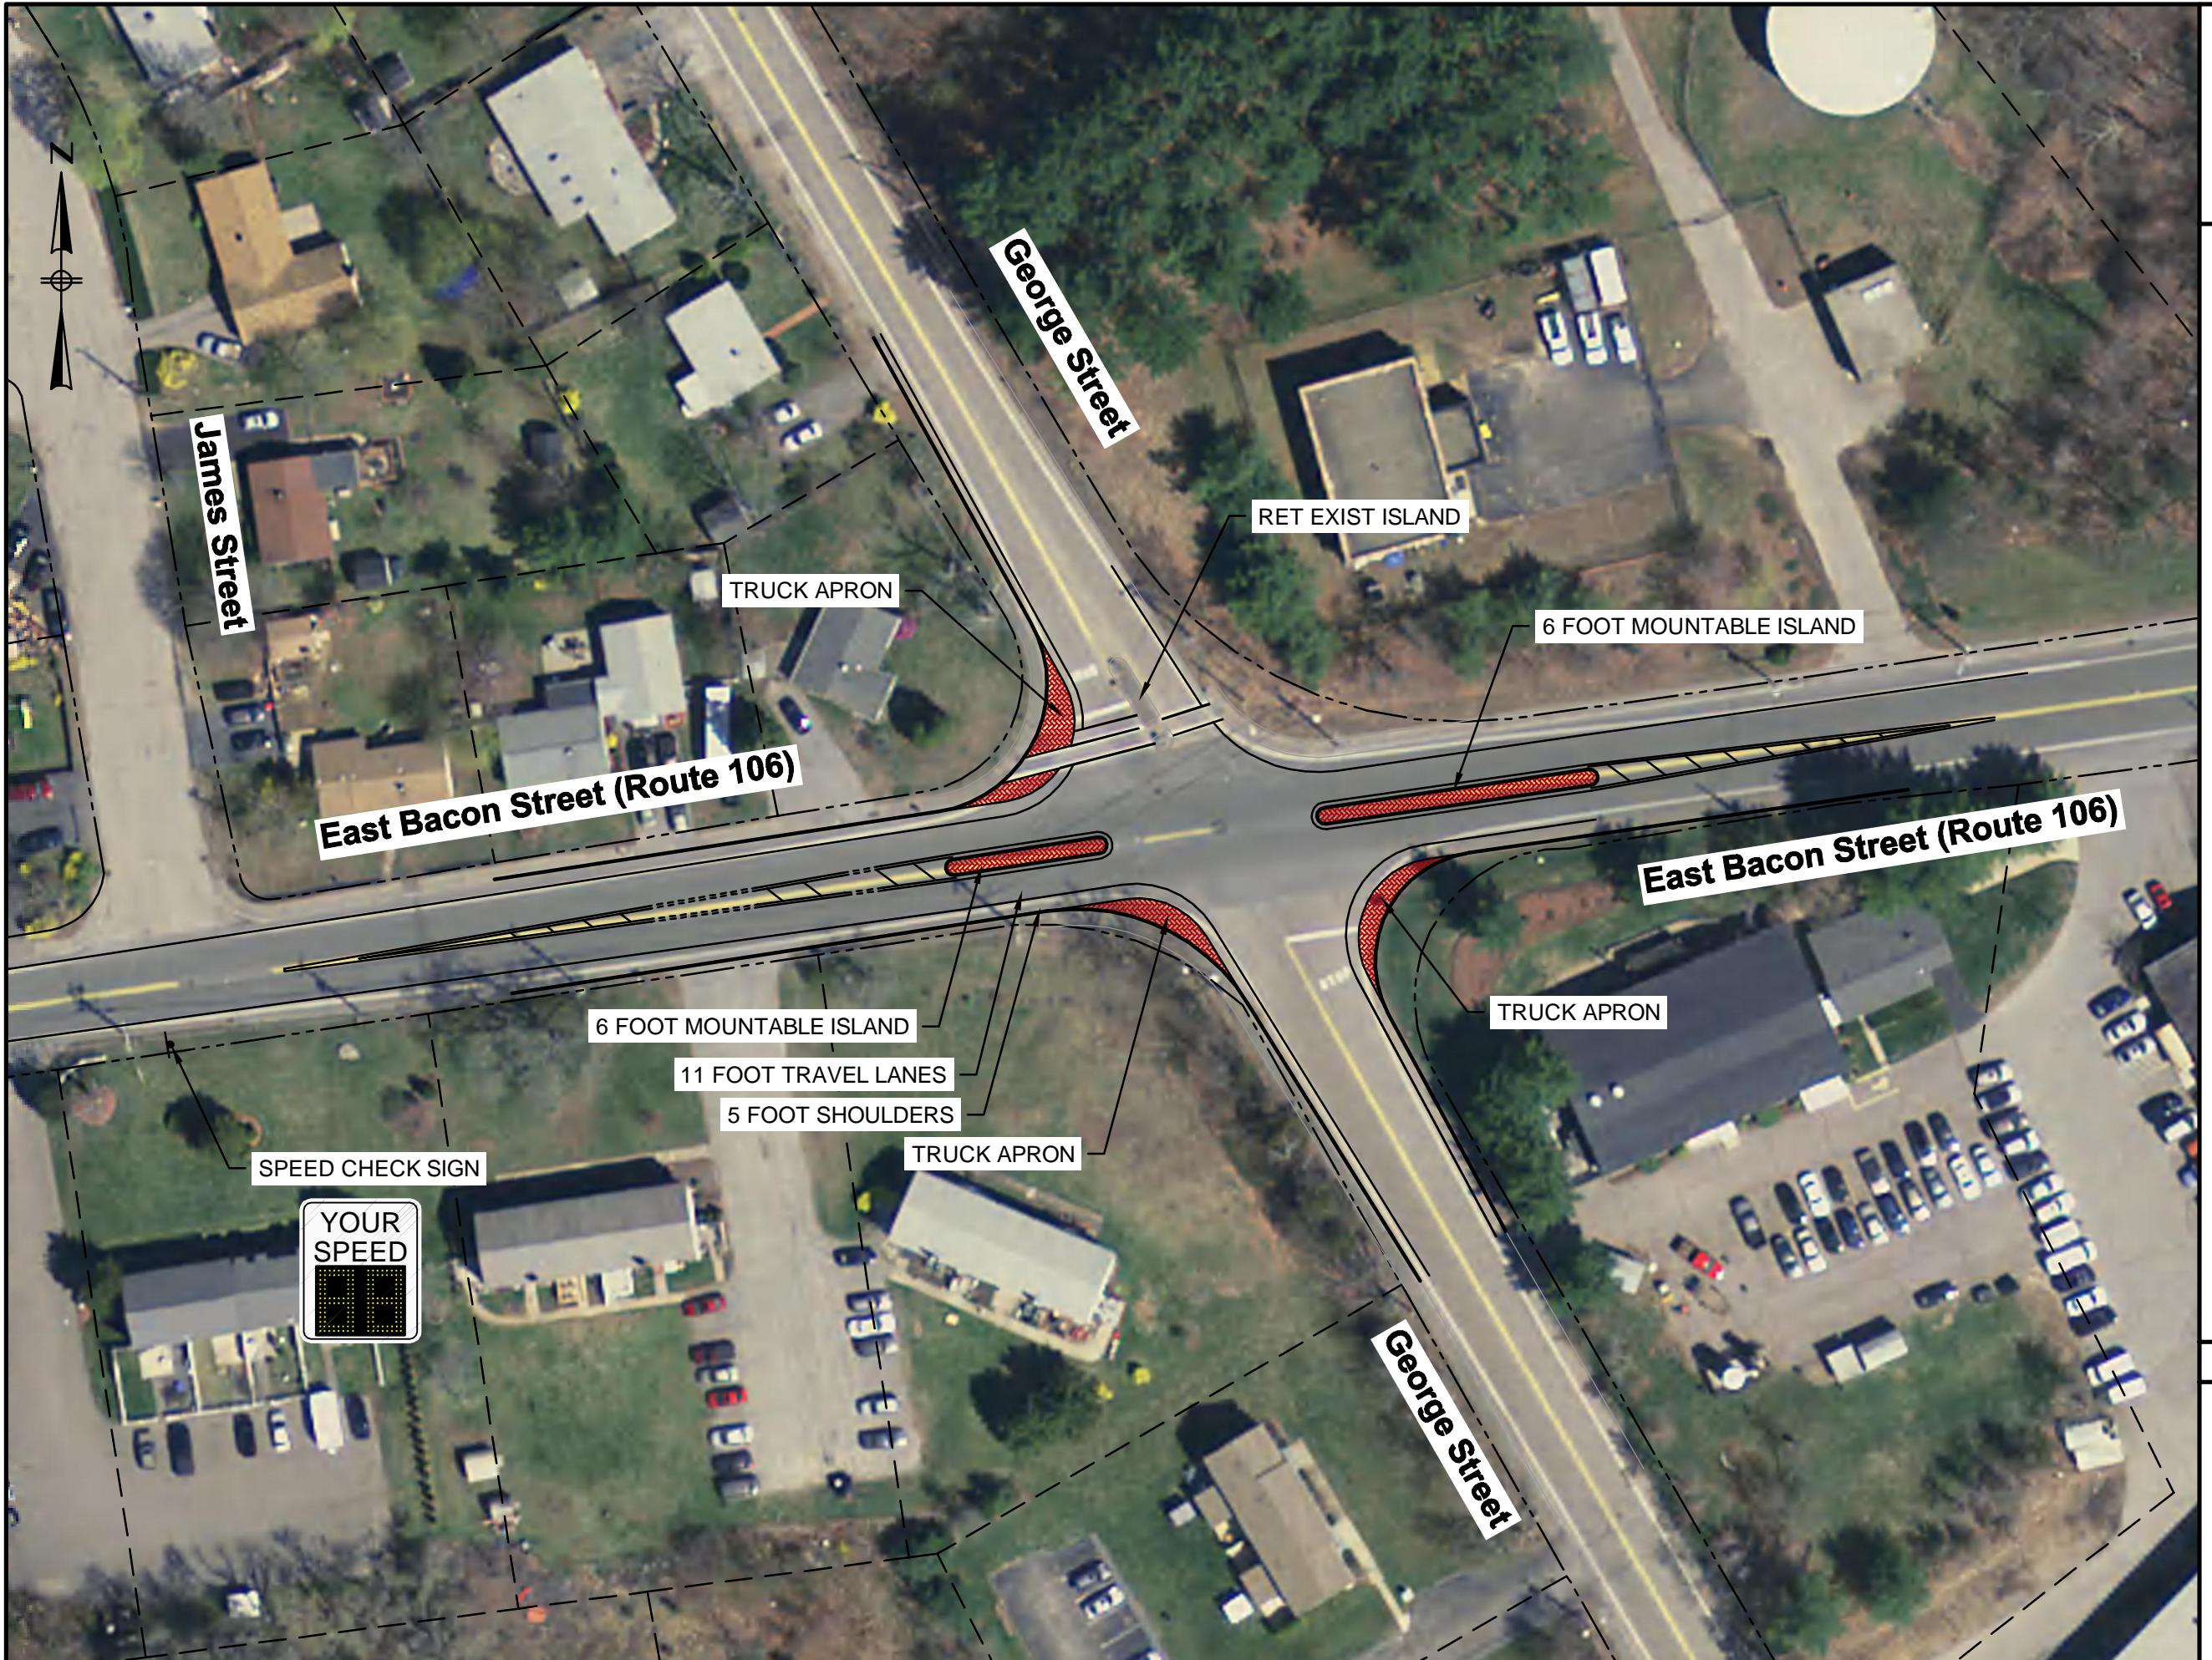
Figure No. 5

**George Street
Concept 1**

Concept 1, shown in Figure 5, recommends the installation of two six foot wide mountable median islands to separate eastbound and westbound traffic on Route 106. A two foot wide shoulder is recommended surrounding the median island. Travel lanes in the area of the island are reduced to 11 feet wide, with a five foot wide shoulder to accommodate bicycles. The diagram also shows the installation of truck aprons on three of the four corners to the intersection. Truck aprons can also be mountable with a sloped edging treatment similar to the median islands which would discourage smaller vehicles from driving on the truck apron. To accommodate drainage conditions, particularly in the area of the existing crosswalk, a flush truck apron could be used without updating the existing drainage infrastructure. This concept recommends the existing island on George Street be retained as this island helps protect vehicles on George Street from the large number of westbound right turns.

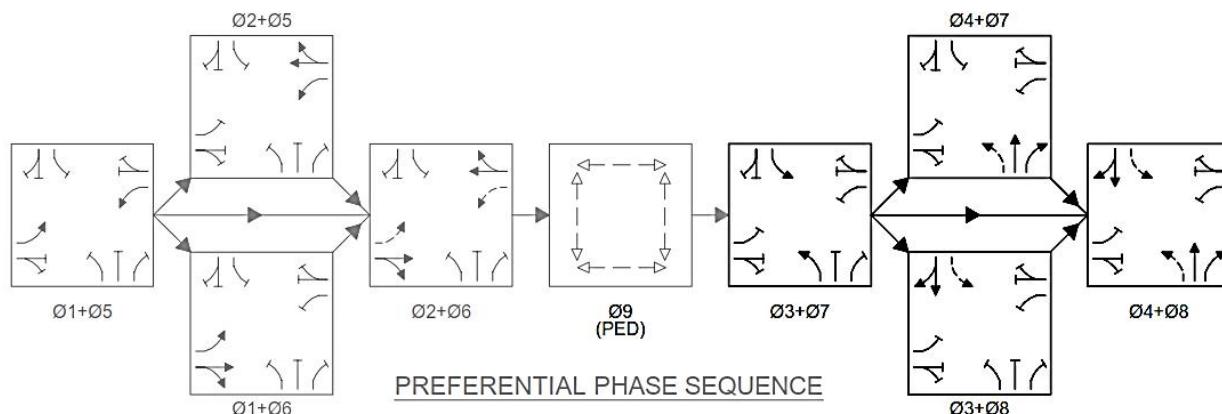
Figure 7: Proposed Phasing Adjustments

Conversely, the intersection could be improved by splitting the northbound and southbound detection into individual phases similar to the operation of the eastbound and westbound detection, see Figure 7. This would allow the controller to skip phases with no vehicle demand and allocate more green to phases with vehicle demand. To obtain this, the pedestrian phase would be moved from Phase 3 to Phase 9 such that the northbound and southbound approaches can follow the NEMA scheme of Phases 3 to 8.

To accommodate this phasing sequence, two additional load switches are required in the controller cabinet.

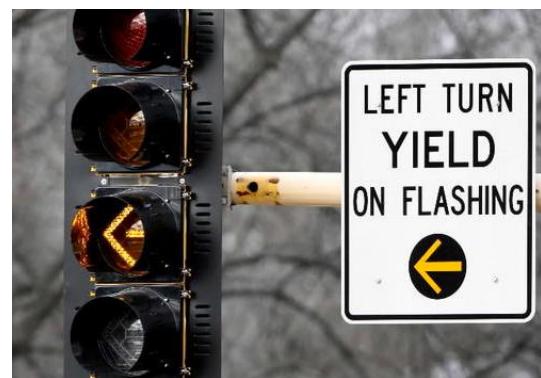
Flashing Yellow Arrow

An alternative to the doghouse style traffic signal arrangement is to provide a flashing yellow arrow (FYA) arrangement. This arrangement displays four left arrow signal heads: Red, Yellow, Flashing Yellow, and Green. Under the protected phase, the standard green arrow, yellow arrow, and red arrow would appear in their typical intervals. During the permitted phase vehicles receive a flashing yellow arrow which alerts drivers that they may proceed but must yield to oncoming traffic. For clarity, a "Left Turn Yield on Flashing Yellow Arrow" (MA-R10-12a) sign should be installed adjacent to the new signal arrangement.
